Renault Laguna Window Regulator Parts to Send & Damage Check

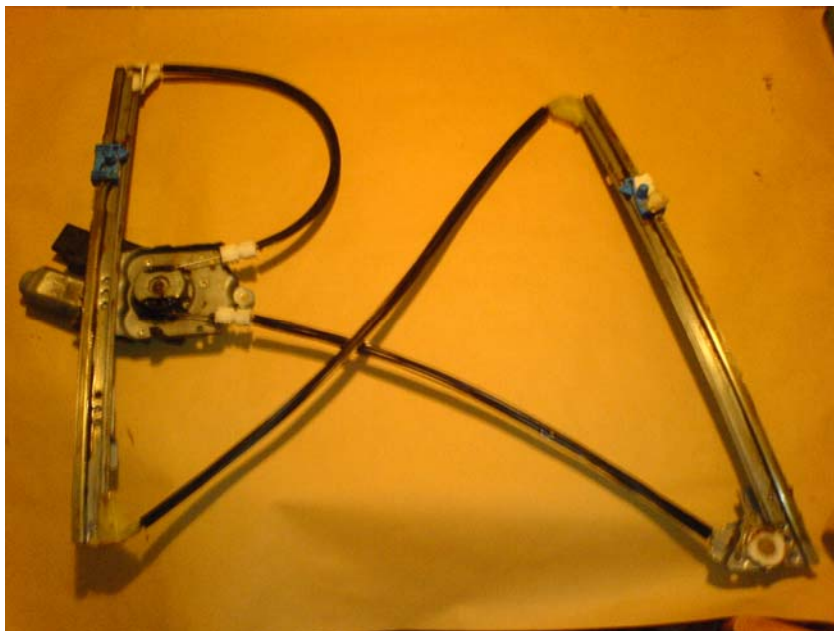
1. Complete Unit

This is pretty much the whole thing, including the motor on the back.

Yours will most likely have the parts hanging off/fell off due to snapped cable.

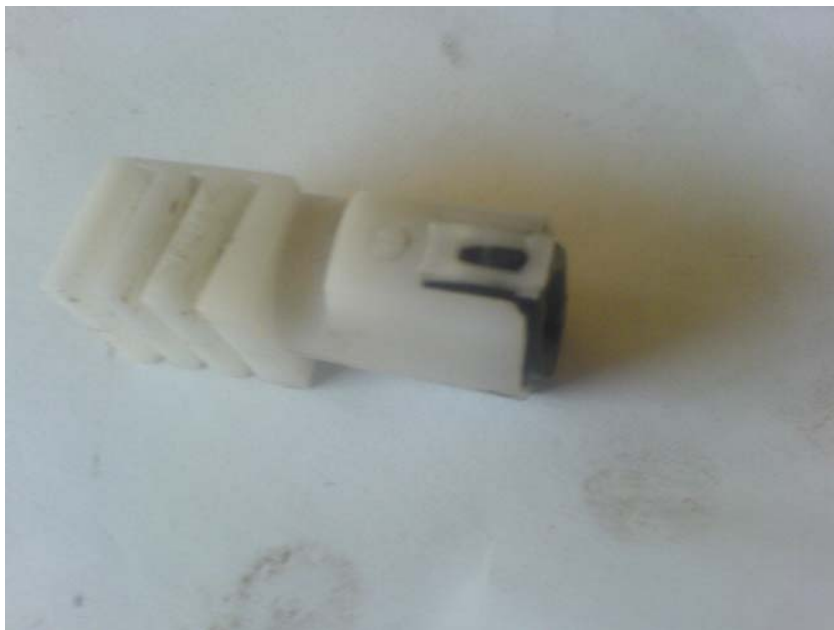
2. Tensioners x2

There are 2 of these, each comprising;

- White housing
- Black cable end
- Spring

These have the habit of dropping off and falling into the door. Ensure you don't lose them as [the unit cannot be repaired without them!](#)

Lost springs are ok, and a missing black cable end is not the end of the world, but the original parts make for a better repair.

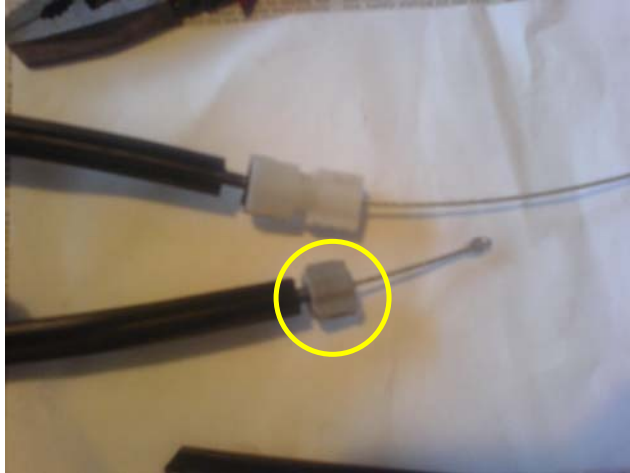
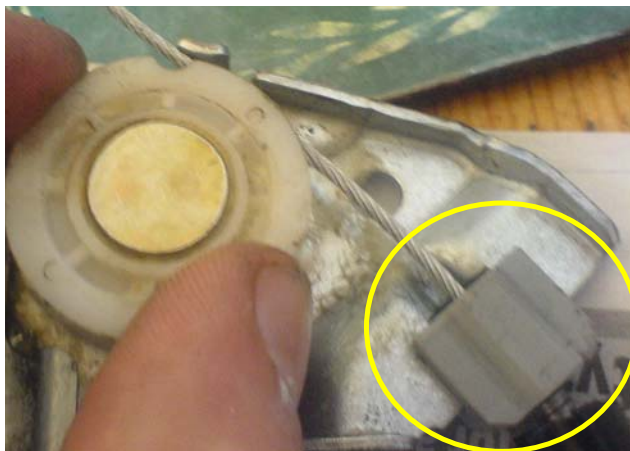
3. Cable Seating (Grey Plastic)

This will probably still be in place either on the frame or on the end of the cable.

This sometimes comes off and drops in the door so again have a good look.

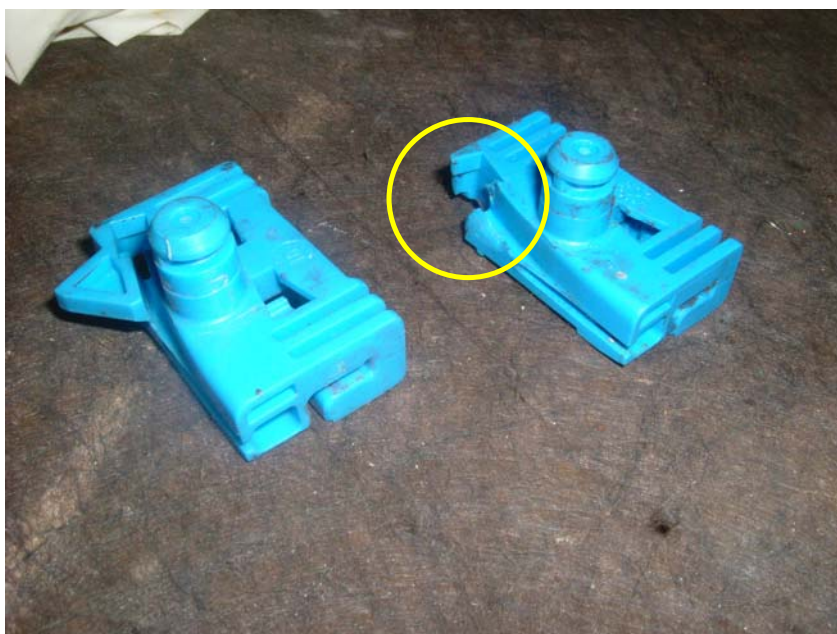
4. Slide Clips (Blue Plastic) x2

There are 2 of these.

They should be still on the frames.

Sometimes they are snapped as circled, however this damage can be repaired.

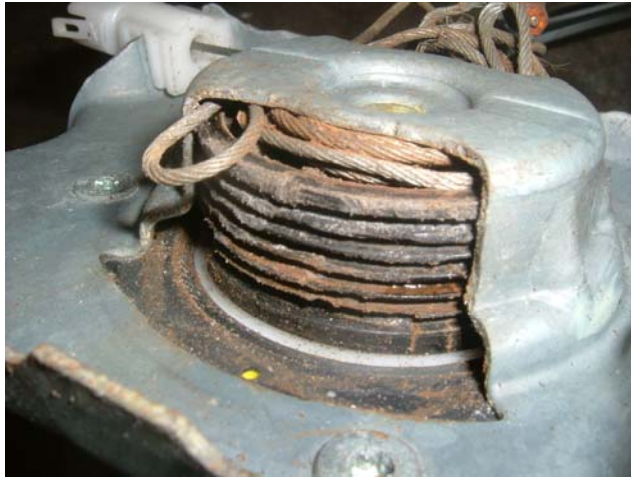
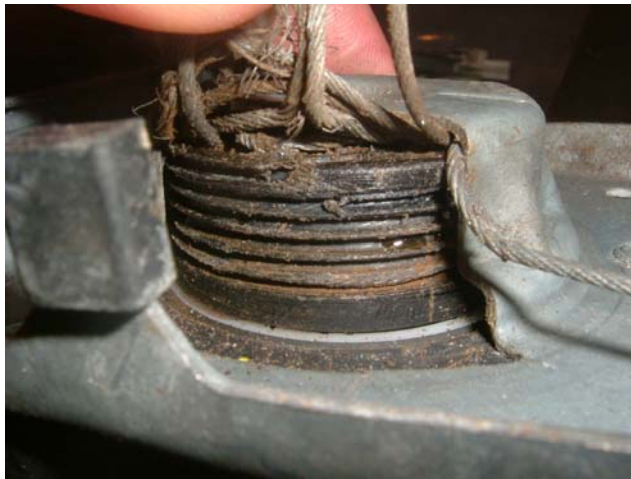
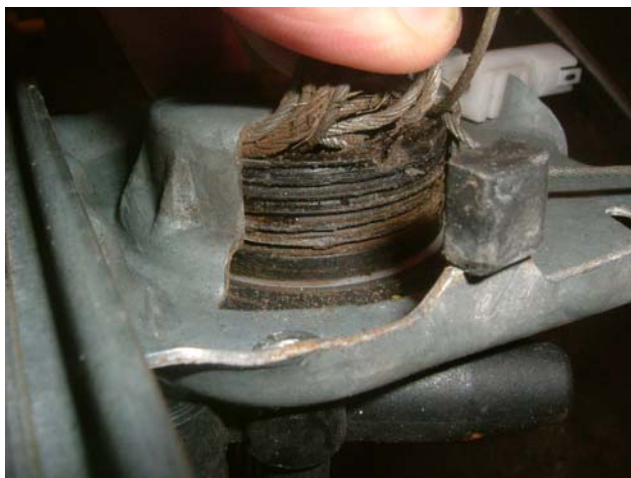
1. Pulley Wheel

These photos are as-is from a regulator that came in for repair, showing the damage to the pulley. In this case it's not too bad and is fully repairable.

Before sending in your regulator it'd be an idea to email me photos from the same angles to assess if it's good to repair or not.
